Client: Queensland Transport

Location: South East Busway, Mt Gravatt (Brisbane, Qld)

Situation: Soil nails had failed in a retaining wall, after heavy rain, causing rotation in the retaining wall.

**CASE STUDY No 4:
SUPPORT FOR FAILED RETAINING WALL**

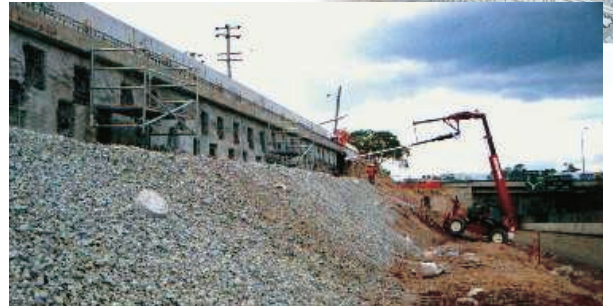
(Above) Screw pile being installed through penetrations cut in the shotcrete wall

Instant Screw Piling devised a procedure for cutting holes in the existing shotcrete wall, installing screw piles, tensioning them, and tying them in to the (repaired) shotcrete wall.

Sections were cut out of the shotcrete wall to allow the screw sections to be driven in. A telescopic handler with a planetary drive head was selected for this job, as it could stand at the base of the wall, pick the screw pile sections from the road above, and install the screw piles. For longer screw piles, shorter sections were butt-welded together. A rock bit was welded to the screw pile to allow it to anchor in rock.
